# **EVALUATION OF VARIOUS TYPES OF PERMEABLE PAVEMENTS WITH RESPECT TO WATER QUALITY IMPROVEMENT AND FLOOD CONTROL**

**Kelly A. Collins, EI; William F. Hunt, PhD., PE; and Jon M. Hathaway, EI**

Biological and Agricultural Engineering

North Carolina State University

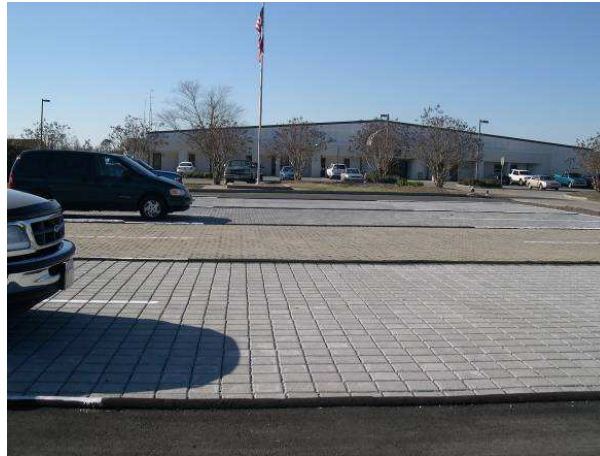
A 20-stall employee parking lot consisting of four different types of permeable pavements and standard asphalt was constructed at the City of Kinston Public Service Complex in Kinston, NC (Figure 1). Area soil maps identified three predominant soils in the near vicinity of the parking area: Lumbee sandy loam, Johns sandy loam, and Johnston soils. All three soils are characterized as poorly drained, level soils with low shrink-swell potential. Prior to lot construction, an on-site soil evaluation confirmed the presence and characteristics of these soils.

**Figure 1. Permeable pavement parking lot in Kinston**

The area of each permeable section is 111.5 sq. m., consisting of four parking stalls. Two standard asphalt sections are located to the outside of the permeable pavement sections. Each asphalt section is 111.5 sq. m (1200 sq. ft.) and consists of two parking stalls. On the ends of both asphalt sections, two 3 by 6 meter (10 x 20 ft) sections of asphalt serve as the entrance ways to the parking lot.

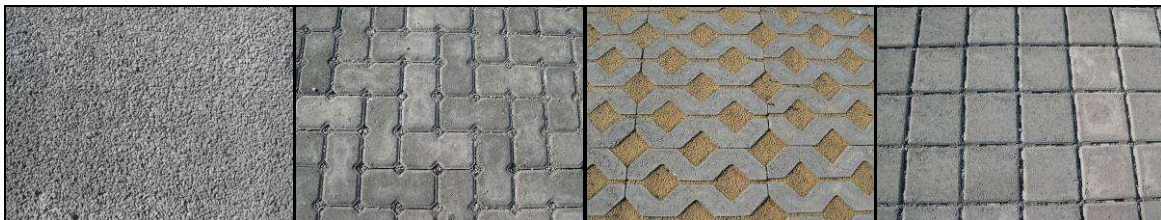
The four permeable pavement sections consist of porous concrete (PC), two sections of permeable interlocking concrete pavers (PICP) with pea gravel fill, and concrete grid pavers (CGP) with sand fill; all of which have been observed industry applications in North Carolina. Of the two PICP sections, one contains ConPave™ Octabrick concrete pavers with a 12.9% void space, and the other SF-Kooperation™ Rima concrete Stone with an 8.5% void space. Images of each pavement type are show below in Figure 2.

**Figure 2. Permeable pavement sections consisting of (from left to right) porous concrete, Octabrick concrete pavers, concrete grid pavers, and Rima concrete stone**

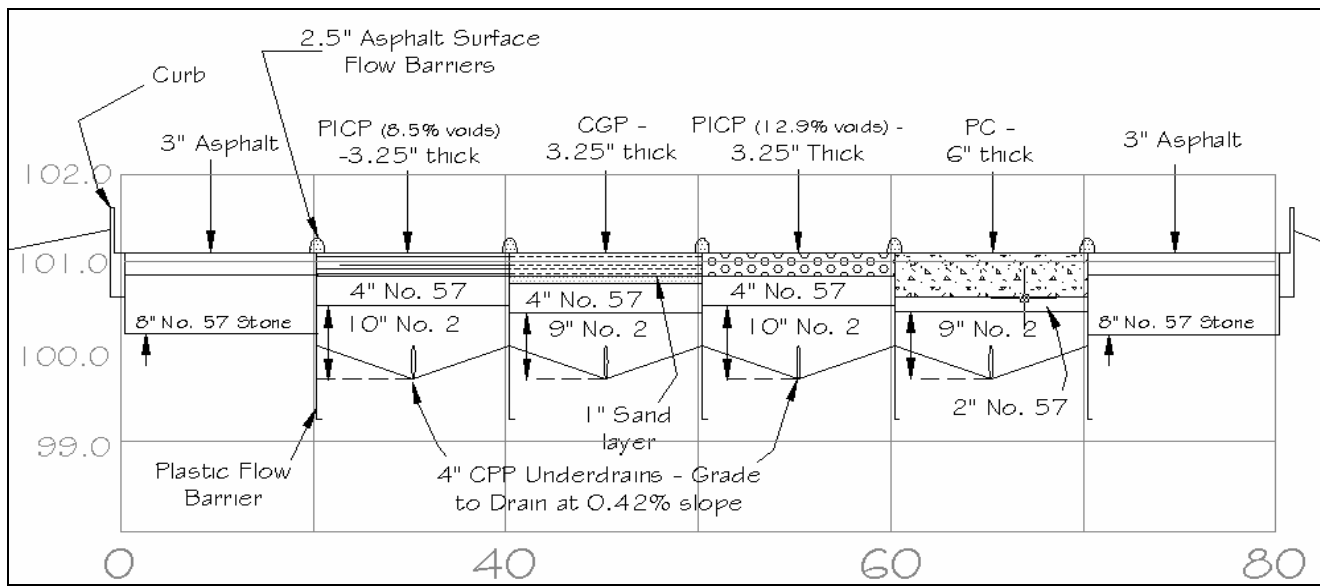
gravel layer serves to support the expected parking lot traffic loading, estimated to be 60 vehicle passes per day. The standard Flexible Pavement Method as defined by the American Association of State Highway and Transportation Officials (AASHTO) was used to determine the structural design requirements for PICP and CGP, based on a 10-year design life and an Equivalent Single Axle Loading (ESAL) of 380. The soil support value was assumed to average a conservative value of 4 for the underlying soils. The environmental factor was set at 1.0, assuming moderate drainage and frequent base layer saturation. The following strength coefficients were used to determine layer thickness: paver with sand/gravel fill (0.20), gravel bedding layer (0.07), and gravel subbase (0.14). For ease of installation, the excavation depth beneath permeable pavements was kept consistent, so the gravel storage layer was adjusted to meet the strength requirements for the limiting pavement design. Figure 3 shows the detailed lot cross section for each pavement type.

**Figure 3. Parking lot cross section (measurements in ft and “ = inches; 1 inch=25.4 mm)**

Assuming no exfiltration, conservative hydraulic analyses indicate that every permeable pavement section would be capable of storing at least 8.9 cm (3.5 in) of rainfall (35% porosity for a 10-inch gravel layer). The two-year, 24-hour rainfall event for Kinston, NC, is approximately 9.65 cm (3.8 in).

Due to the poor drainage nature of the site soils, underdrains were installed to drain permeable pavement exfiltrate. Beneath each permeable section, at the bottom of the subsurface storage layer, one perforated 10 cm diameter section of corrugated plastic pipe runs the length of the parking lot. The subsurface of each permeable pavement slopes to these corrugated underdrains to allow water entering the pavements to flow out of the system.

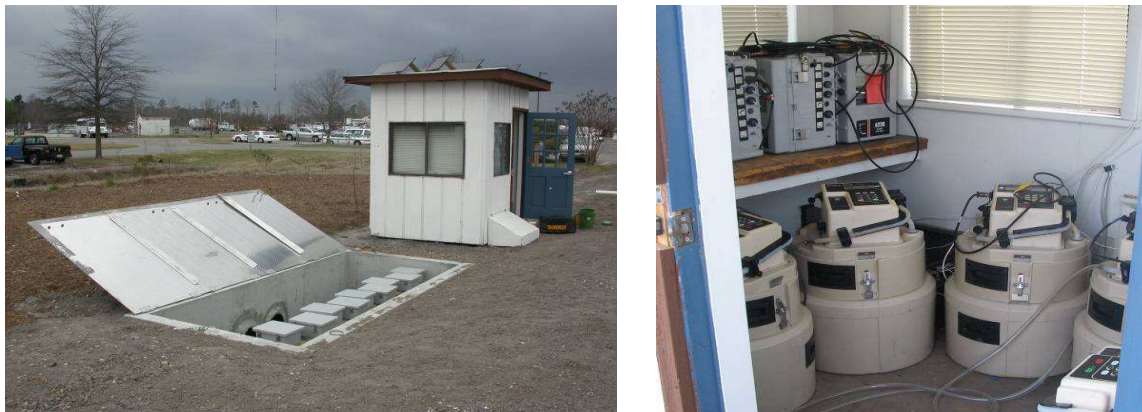
A 3.96 x 1.83 x 0.91 m (13 x 6 x 3 ft) concrete monitoring vault is located down slope of the parking lot, approximately 3 meters (10 ft) from the edge of the parking lot curb. The vault has been placed so that positive drainage occurs from all monitored sections of the parking lot into this vault. All water measurements and sampling occur within this vault, from where the water then drains via two 25.4 (10 in) cm culverts to a nearby stream. Electronic sampling units are housed adjacent to the vault in a monitoring shed (Figure 4).

Figure 4. Monitoring vault and shed (left) with detail of sampling equipment (right)

During each rainfall event, flow weighted water quality samples of the surface runoff from each of the two asphalt regions are collected. Additionally, flow weighted exfiltrate samples from each permeable pavement section are also collected. Six total sections are sampled individually using Sigma 900 and Sigma 900Max automatic samplers. Runoff and exfiltrate from rainfall events of 0.25 cm to 5.0 cm (0.1-2.0 in) in size are being collected. ISCO 4230 flow meters continuously measure water elevations in the weir boxes for each of the sections being evaluated for water quality. Changes in head level, indicating flow through the system, trigger water quality sampling via the Sigma 900's and 900Max's to begin. Sampling continues until head levels return to their initial readings.

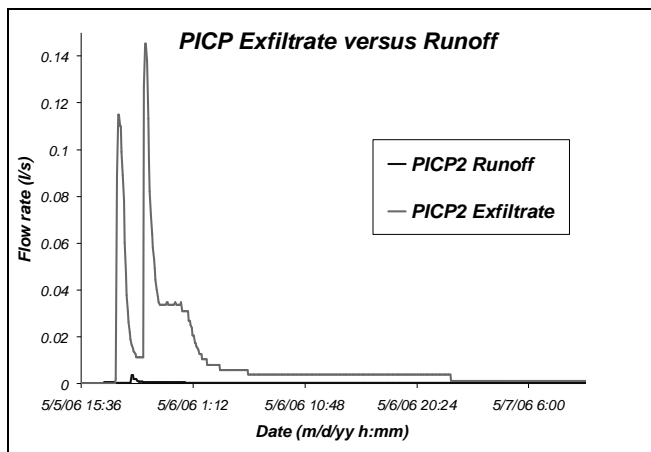
All permeable pavement sections have shown dramatic reductions in surface runoff volumes. During most storm events, very little to no surface runoff has been observed on the porous concrete and PICP sections. It is important to note that rain falling on the uncovered gutter flows directly to the surface drains of each permeable section, thereby contributing to a small portion of the runoff data. Graphed below (Figure 5) is a runoff versus exfiltrate curve for the PICP with 8.5% void space during a 2.24 cm (0.88 in) rainfall event.

**Figure 5. Exfiltrate versus runoff hydrograph for PICP with 8.5% voids**

Figure 5 is typical of the runoff versus exfiltrate curves for the porous concrete and both PICP sections. Comparatively, a larger amount of surface runoff for the grid pavers filled with sand has been observed. The same 2.24 cm rainfall event yielded the hydrograph show in Figure 6. Overall, there is a greater volume of runoff from this section, as well a higher runoff peak flow rate.

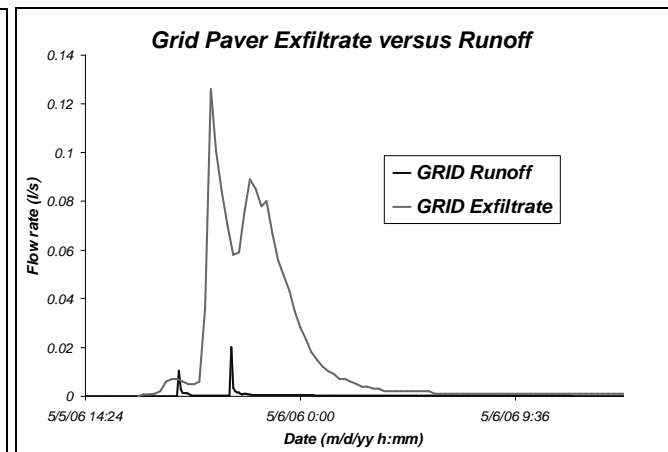
**Figure 6. Exfiltrate versus runoff hydrograph for grid pavers**
